***Environmental Baseline Survey at
North Truro Air Force Station,
Truro, Massachusetts***

***Final
November 1994***

Radian Corporation
155 Corporate Woods, Suite 100
Rochester, New York 14623

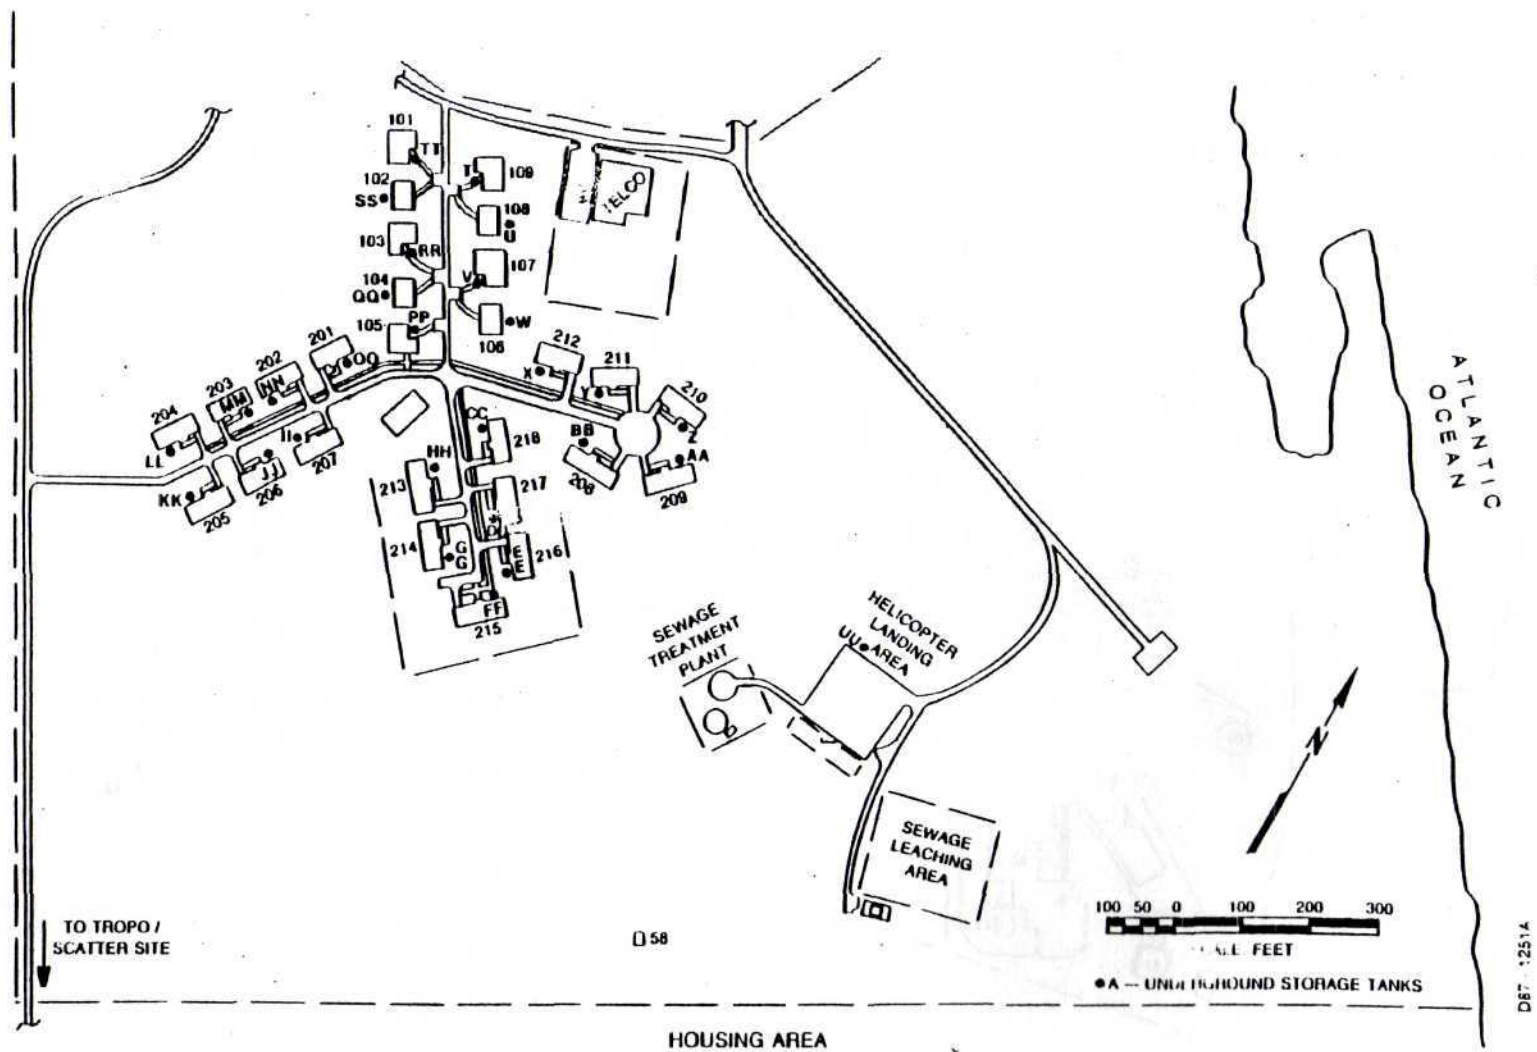
Figure 3-3. Location of Underground Storage Tanks, Housing Area

There were a total of 49 underground storage tanks (USTs) at the Station; 19 in the Support Area, 29 in the Housing Area, and 1 at the GATR site (listed in Table 3-2 and shown in Figures 3-2 through 3-4). During the period of operation, tanks contained various grades of fuels (diesel, gasoline, furnace oil, etc.) and waste oils. All tanks were asphalt-coated carbon steel. No secondary containment or overfill protection was provided for the tanks since, at the time of installation, these technologies were not commonly used or required.
